Inspection Report

**Property Address:
2007 Skinner Road
Winter Park, FL 32792**

Date: 9/3/2007	Time: 12:32 PM	Report ID: 080107-2
Property: 2007 Skinner Road Winter Park, FL 32792	Customer: William Thompson	Real Estate Professional: George Smith Sample Realty

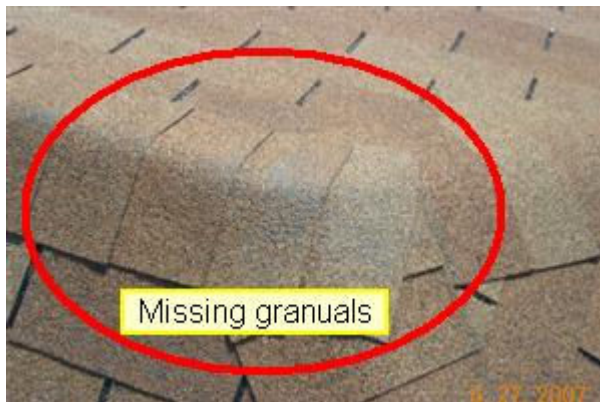
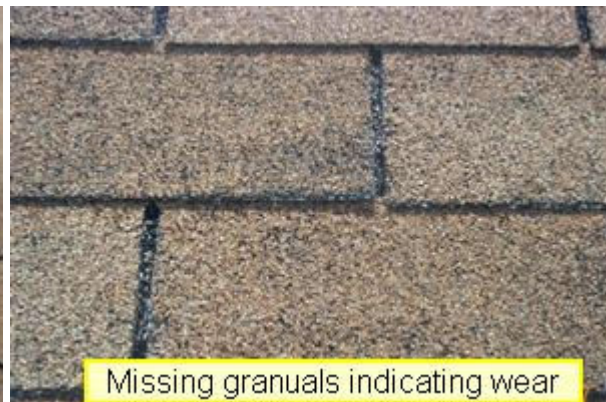
The roof covering shows signs of wear in several locations. The client should plan on replacing the roof covering in the near future to prevent possible leaks. **I recommend having a licensed contractor evaluate the roof covering for a more precise estimate of the remaining life.**

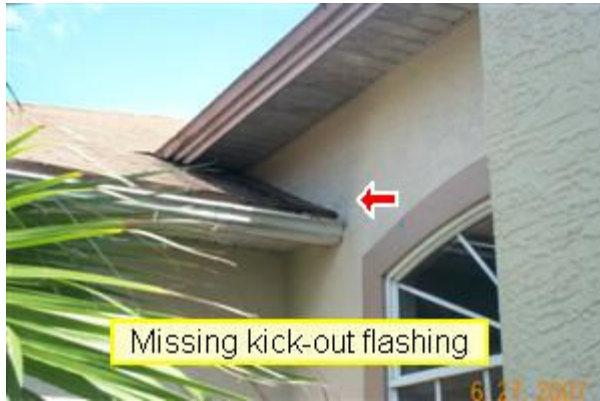
1.1 Picture 1

(1) Some flashings are not visible due to being covered by shingles and/or exterior cladding. The visible flashing were inspected and the condition of those that were not visible are assumed to be in a similar condition.
- (2) Missing kickout at front wall.

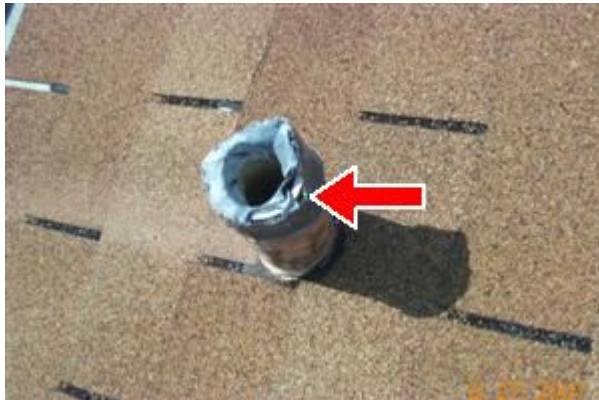
1.2 Picture 1

- 🏠 The plumbing vent pipe boot flashings are damaged and need to be replaced. Damaged boot flashings will allow rain to run down the side of the pipe and enter the homes walls where it can cause unseen damage. Recommend replacement by a licensed roofing contractor.

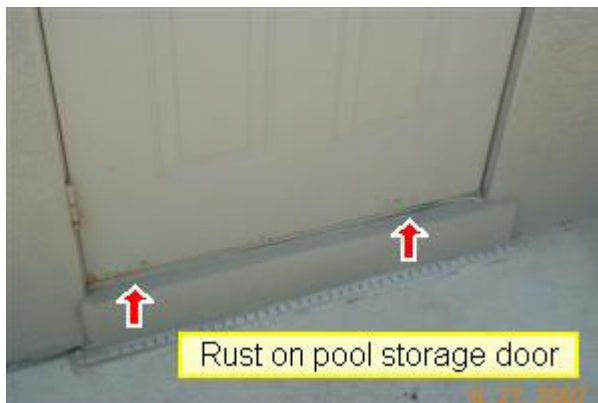
2.2 Picture 1

The door to the storage area by the pool shows some rusting. This should be repaired to prevent further deterioration.

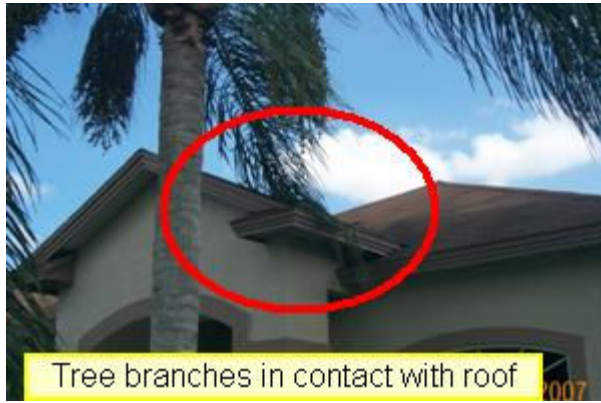
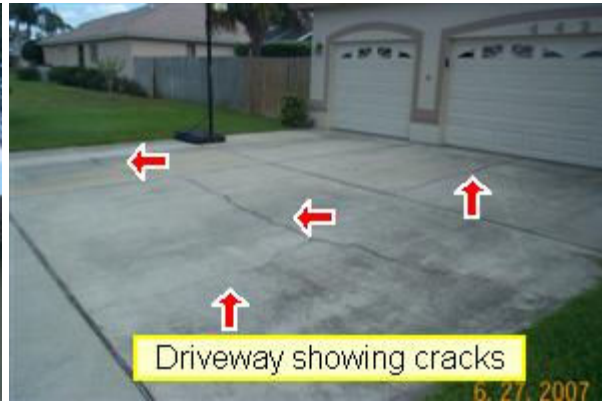
The driveway is exhibiting cracks that are consistent with the age of the structure. The driveway appears to be functional at this time. The cracks should be monitored and repaired as needed.

The tree limbs that are in contact with roof or hanging near roof should be trimmed.

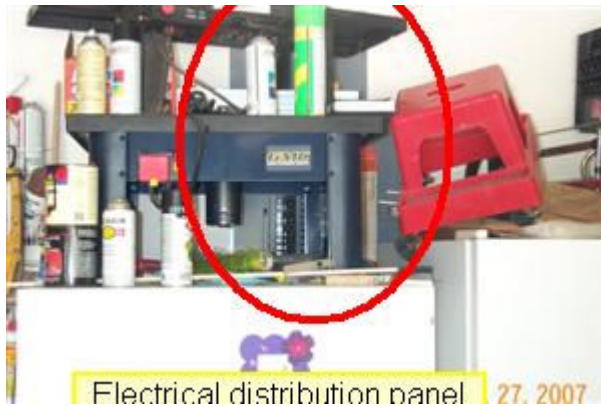
6.1 Picture 1

Distribution panel was not accessible for inspection.

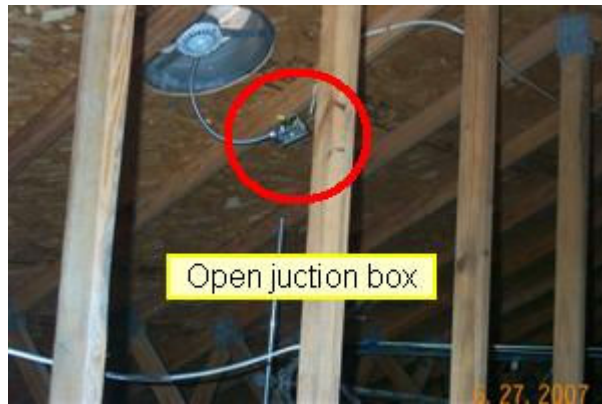
6.3 Picture 1

There is an open junction box with unrestrained wiring at the connection to the attic exhaust fan. Unrestrained wiring going into a metal junction box could wear through the insulation on the wire

and result in an energized surface or cause a fire. Recommend that this be addressed as soon as possible by a licensed electrical contractor.

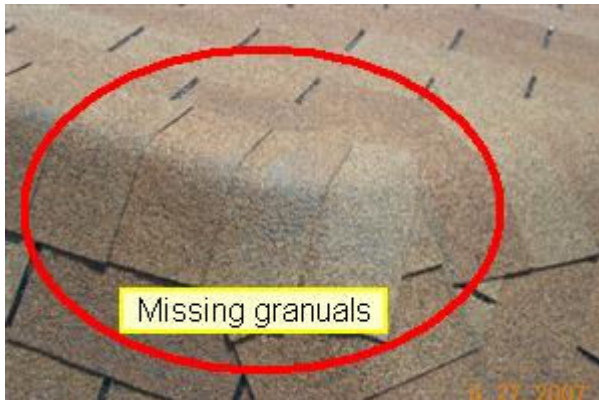
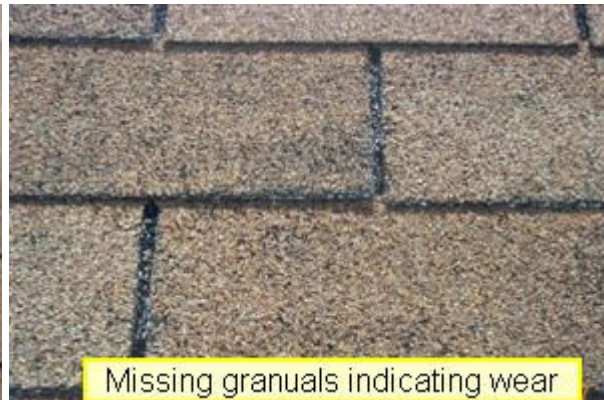
The roof covering shows signs of wear in several locations. The client should plan on replacing the roof covering in the near future to prevent possible leaks. **I recommend having a licensed contractor evaluate the roof covering for a more precise estimate of the remaining life.**

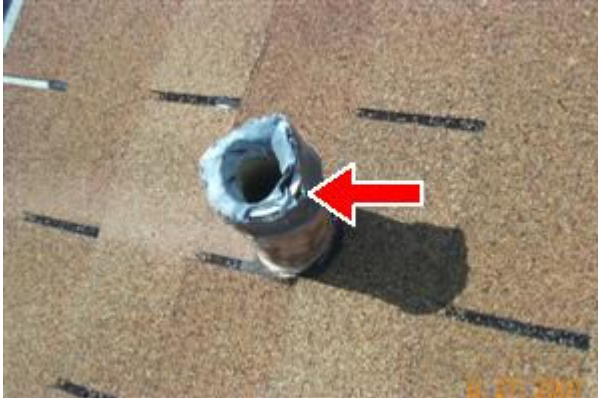
1.2 Picture 1

- 🏠 The plumbing vent pipe boot flashings are damaged and need to be replaced. Damaged boot flashings will allow rain to run down the side of the pipe and enter the homes walls where it can cause unseen damage. Recommend replacement by a licensed roofing contractor.

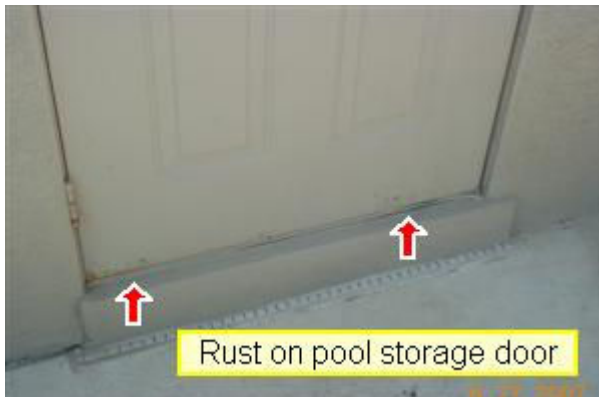
2.2 Picture 1

- 🏠 The door to the storage area by the pool shows some rusting. This should be repaired to prevent further deterioration.

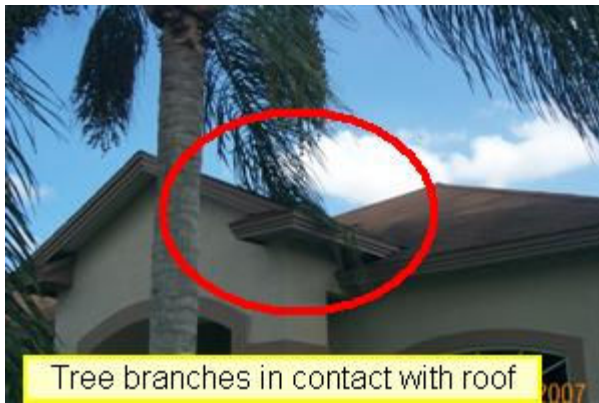
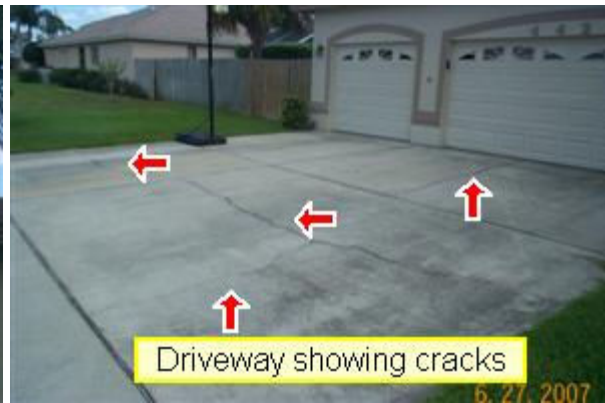
- 🏠 The driveway is exhibiting cracks that are consistent with the age of the structure. The driveway appears to be functional at this time. The cracks should be monitored and repaired as needed.

The tree limbs that are in contact with roof or hanging near roof should be trimmed.

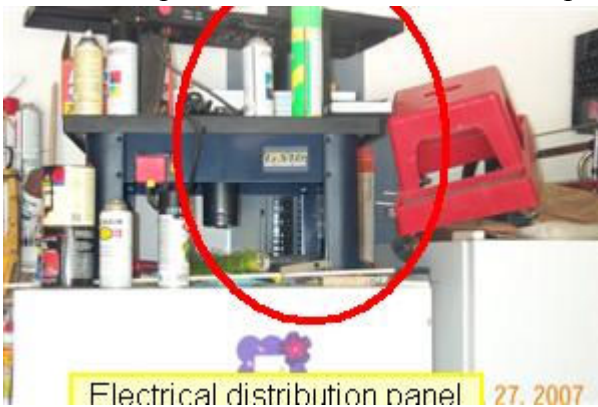
6.1 Picture 1

- ⚡ Distribution panel was not accessible for inspection.

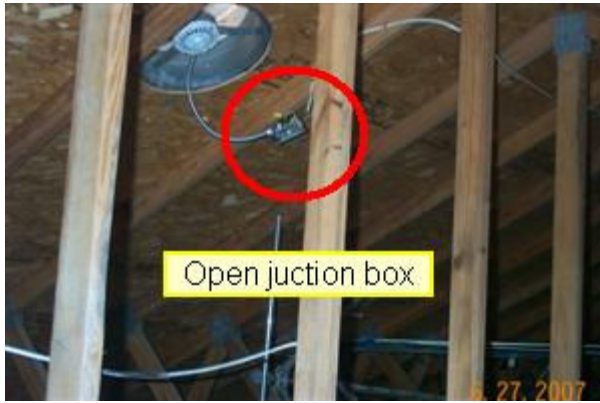
6.3 Picture 1

- ⚡ There is an open junction box with unrestrained wiring at the connection to the attic exhaust fan. Unrestrained wiring going into a metal junction box could wear through the insulation on the wire and result in an energized surface or cause a fire. Recommend that this be addressed as soon as possible by a licensed electrical contractor.
